An Analysis of a Historical House in Alaçatı, Çeşme

3. Yürük House and Grocery

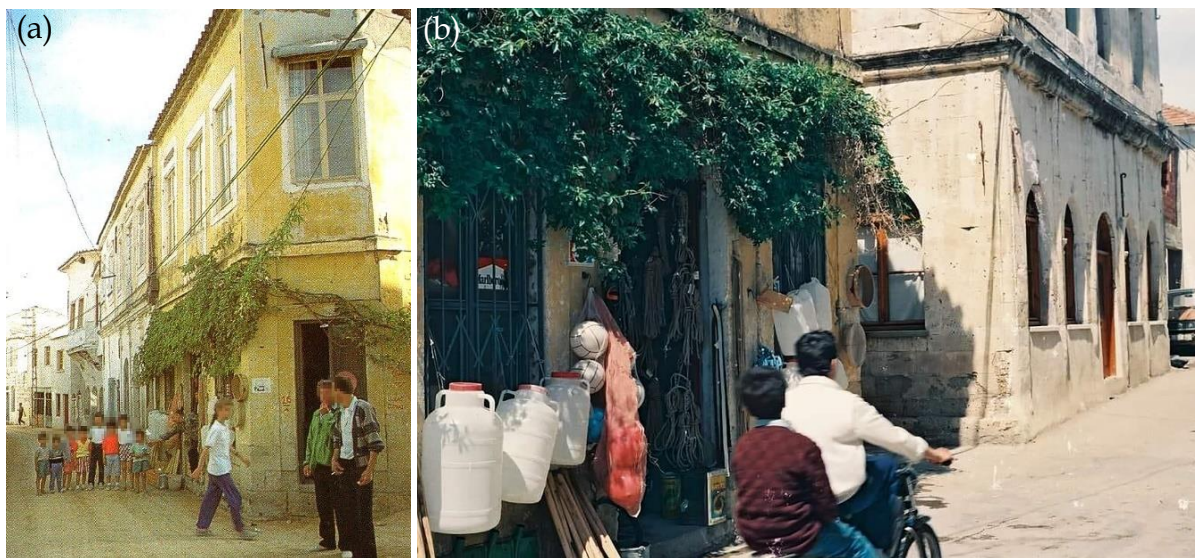
Figure 4. “Yürük Grocery” in the early 1990s; (a) the window at the corner converted into a door, (b) eastern façade (URL2)

In the recent period when the building was used as a grocery store, changes were made to the ground floor façade. While the original wooden door was preserved, the windows were fitted with double-winged iron frames and fixed iron grille. The original window on the corner was enlarged and turned into a double-winged iron-framed door. The front façade of the structure is covered with a large ivy. On the upper floor, the balcony usage was canceled by the users, or the demolished balcony was replaced with a window instead of a door opening. The wooden shutters have disappeared, and as seen in old photographs, the windows were originally double-winged, unglazed, and wooden. The wall and chamfered section of the north façade of the main room were repaired and renewed after damage and demolition to the original wall. Traces from the building, oral history research, and old photographs show that the kitchen and toilet were renewed with modern construction techniques after damage and demolition to the original walls and flooring. These areas feature concrete flooring and ceramic tiles.

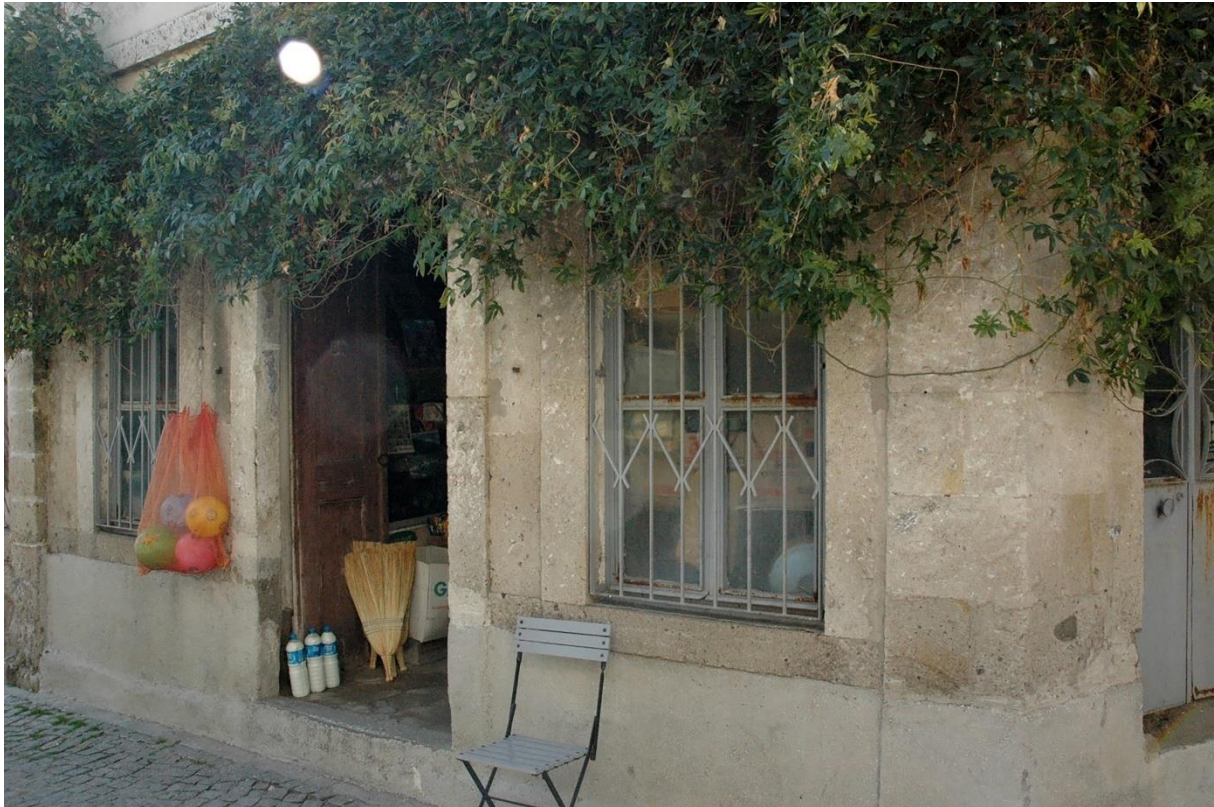
Figure 5. Main entrance of “Yürük Grocery” in 2011 (URL3)

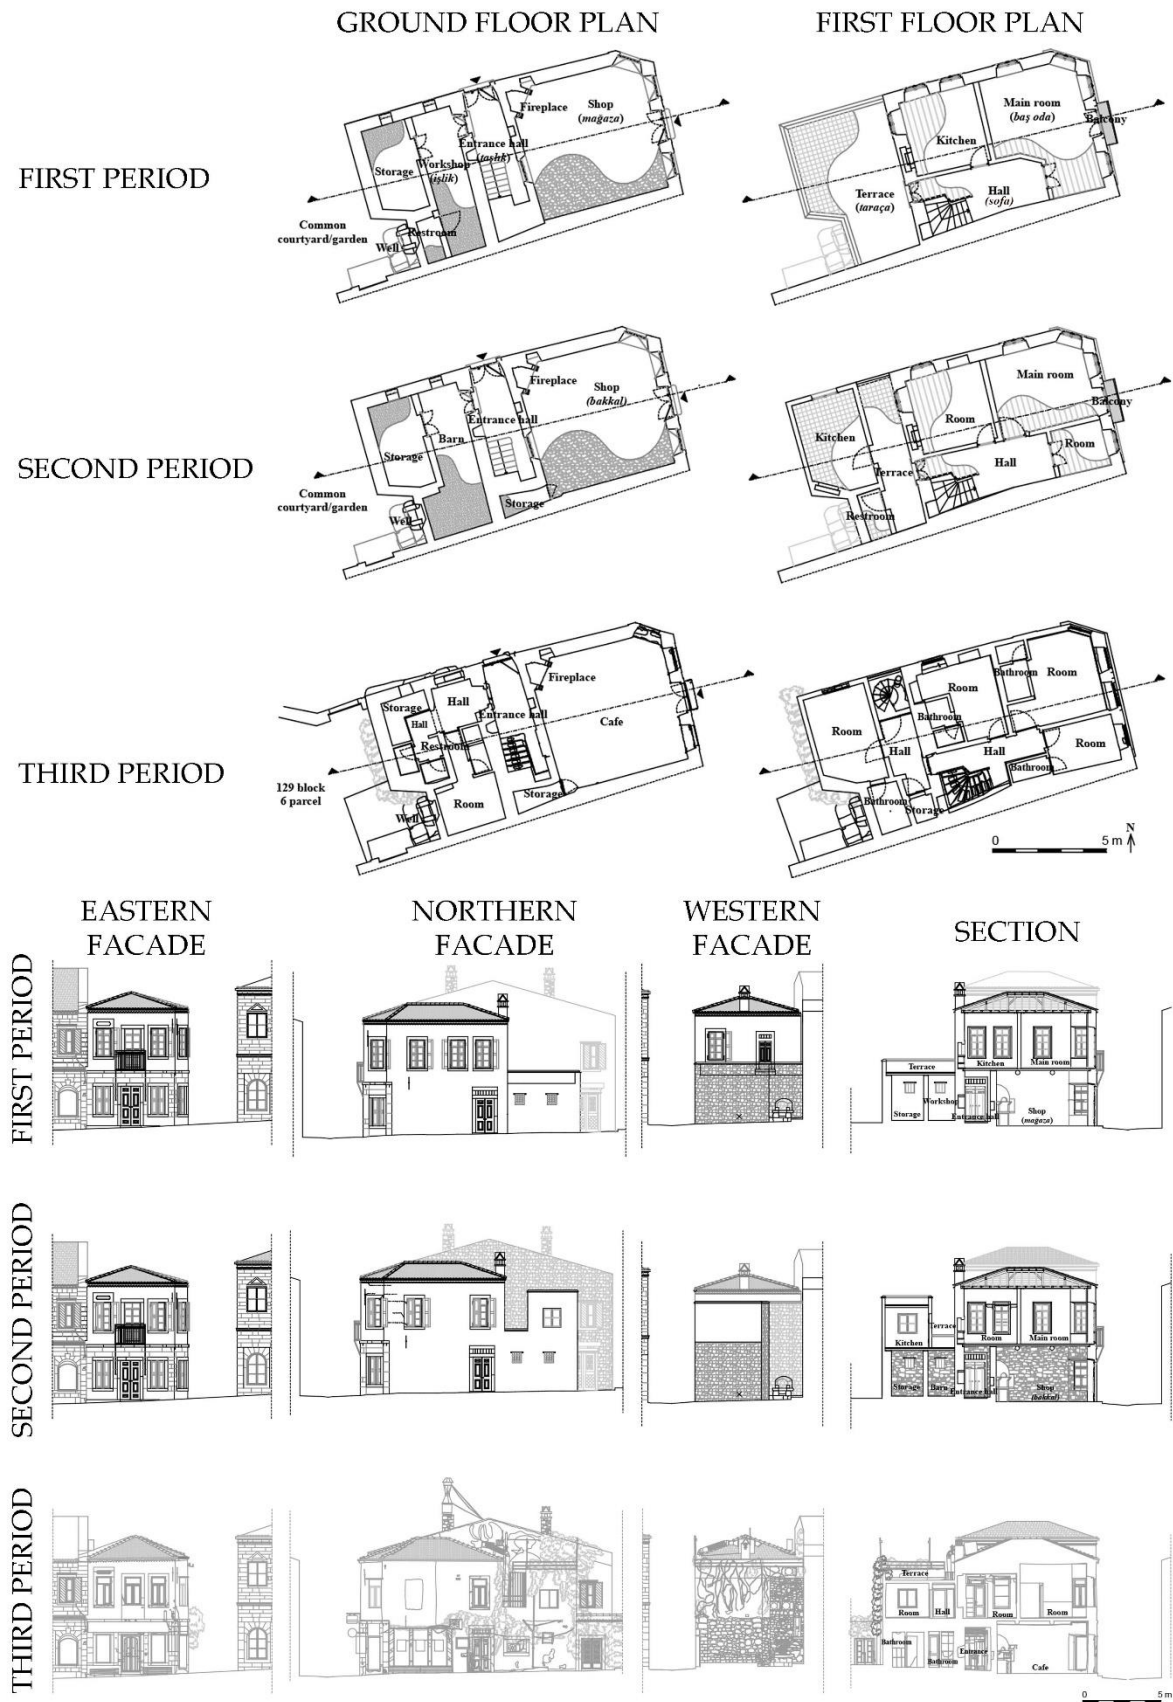
Figure 6. Drawings showing the three periods of the building

In the third period (probably after 2010s), the building gained its current function of accommodation (boutique hotel) and commerce (café), reaching its present physical state (Figure 7). This period describes the building's current condition (Figure 6).

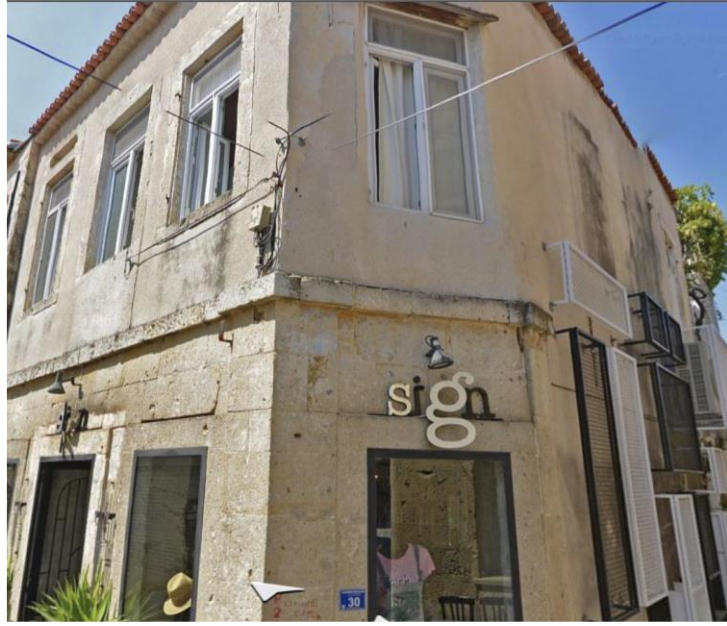
Figure 7. Façade view of the building in 2015 (Yandex, 2015)

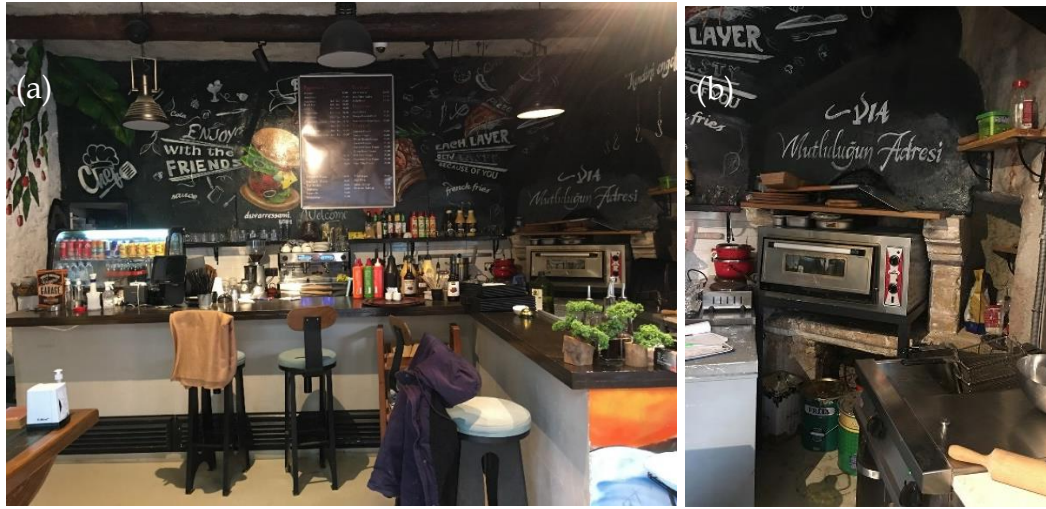
The stone-framed door and window openings leading from the street to the shop are original. It has been found from traces in the building and oral history research that the shop is connected to the entrance hall through a window opening. It has been determined through traces from the structure and oral history research that the shop was connected to the entrance hall by a window opening. There is an original stone fireplace located at the corner of the shop (Figure 8). Right next to this fireplace, there is an original niche in the wall. The shop features original iron hook eyes belonging to the doors and windows. Based on traces from the building and comparative studies with surrounding buildings, it has been determined that the stone-framed, stone-silled windows were covered with wooden shutters. The stone-framed door, as seen in old photographs of the building, is a double-winged wooden door. It is known from traces in the building, old photographs, and oral sources that the original window at the corner was converted into a door for a period, but it has been restored as a window today. According to written sources and comparative studies with surrounding buildings, the walls are made of unplastered stone. On the opposite wall of the entrance door, on the western wall of the space, there is a trace that protrudes from the wall. According to information obtained from oral sources, this trace belongs to the opening that connects the entrance hall with the shop. This opening is believed to have a stone frame and wooden shutters based on comparative studies within the building. The original flooring of the shop has been identified as stone, based on traces from the building and information from written sources. The two wooden beam rafters in the ceiling are original (Figure 8). In the second period, according to traces from the building, a storage area was added under the stone staircase to serve the shop. Additionally, changes were made to the ground floor façade while the building was used as a grocery store. While the original wooden door was preserved, double-winged iron frames and fixed iron grilles were installed on the windows instead of wooden shutters. The original window at the

corner was enlarged and converted into a double-winged iron-framed door. The ivy on the front façade is notable in this period (Figure 4).

Figure 8. In 2021, (a) shop used as a café and (b) fireplace

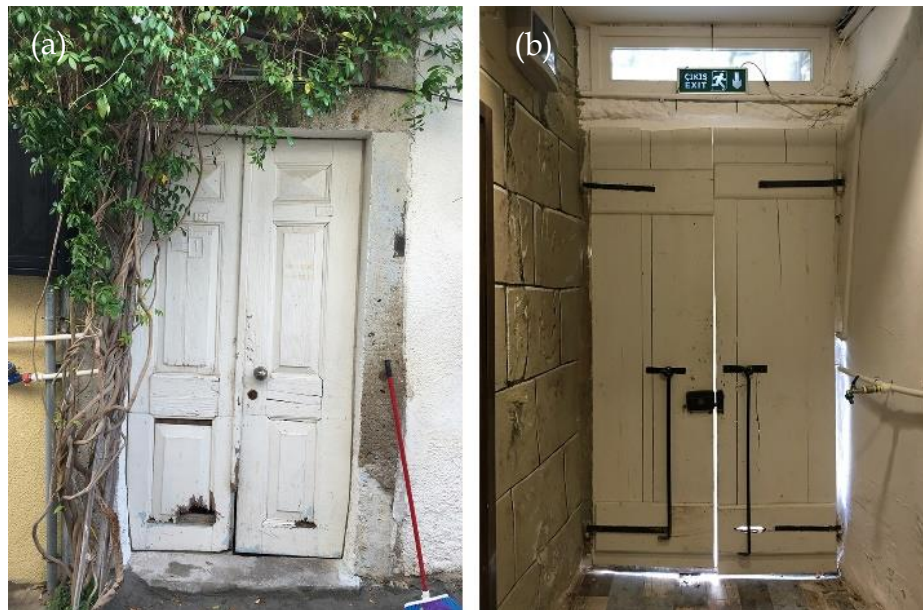
The stone-framed, double-winged wooden door with a vent on top, providing access from the side street to entrance hall, is original (Figure 9). In the entrance hall, there are two original stone niches facing each other. Access to the service spaces, including the workspace, storage, and toilet, is provided through the original stone-framed opening. Based on a comparative study in the building, this opening has been closed with a double-winged wooden door. The original L-shaped stone staircase in the entrance hall leads to the living floor (Figure 10).

Figure 9. Original wooden door in the entrance hall (a) front, (b) the back

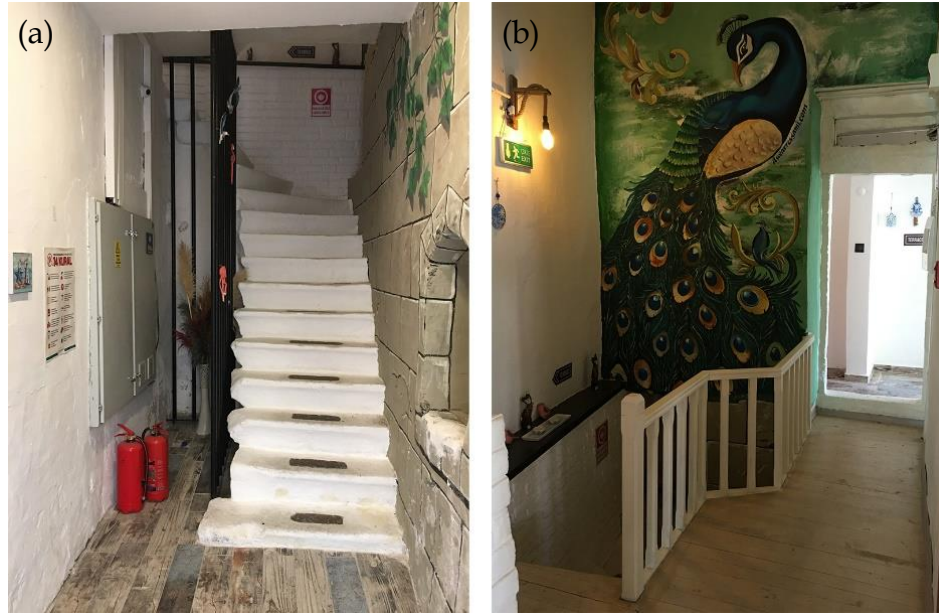
The walls, according to information from written sources and comparative studies with surrounding buildings, are made of unplastered stone. The original flooring of the entrance

hall, as seen in old photographs and written sources, is made of stone. The original ceiling, according to a comparative study within the building and information from written sources, consists of wooden beams. The walls of the entrance hall, as seen in old photographs, are plastered and painted.

Figure 10. Entrance hall with (a) stone staircase and (b) wooden balustrade, in 2021

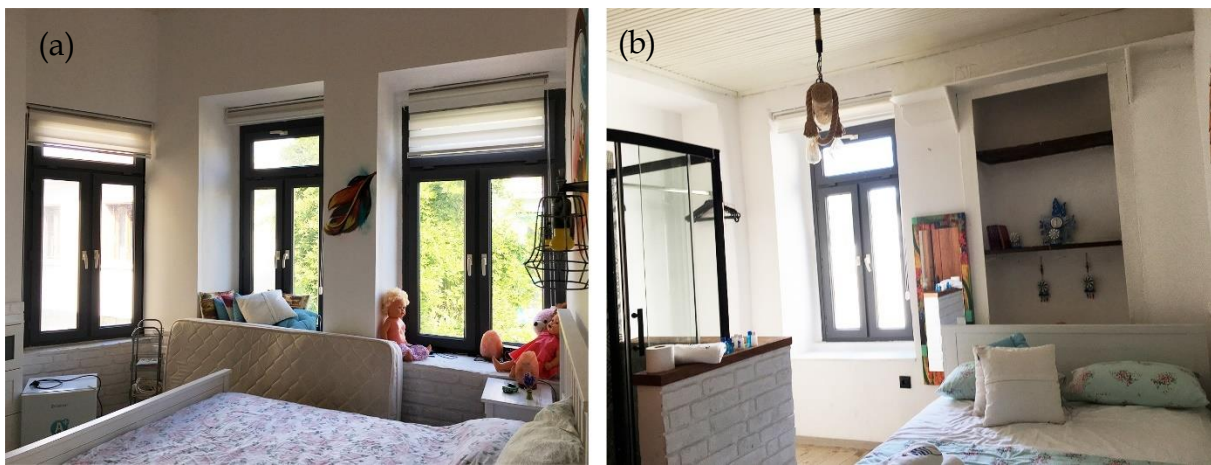
The double-leaf wooden door providing access from the hall to the main room was determined based on a comparative study with the surrounding area (Figure 11). Based on traces from the building, it is clearly understood that one corner of the main room has a beveled edge (as the original wall continues in a beveled manner). In the main room, the vented window directly opposite the door, along with the vented door opening to the terrace, serves the purpose of ventilation (Terim, 2011). There is a window opening on the north façade that was later closed by the users. Based on a comparative study with the surrounding area, in its original state, the double-leaf wooden windows facing the front and side façades are wooden shuttered, with wooden sills (as determined in a comparative study within the building) and stone jambs. The original iron hinges for the wooden shutters are located on the façade. In the main room, based on traces from the building, oral history research, and a comparative study with the surrounding area, it is understood that there was a balcony. The original stone-framed door leading to the balcony was later closed by the users and converted into a window. A double-leaf wooden door was placed in this opening, based on a comparative study with the surrounding area. The balcony, based on a comparative study with the surrounding area, is framed with iron railing and its floor is covered with timber. The walls were originally plastered and painted. The original floor, based on a comparative study within the building, consists of timber. The original ceiling, according to information from written sources and a comparative study with surrounding buildings, is a wooden beam ceiling. In the second period, it is believed that the users divided the main room into two (by demolishing most of the beveled wall) with a brick wall to create an additional room. The entrance to the main room, based on traces from the building, is through a single-leaf wooden door. The balcony in the main room has either been removed or its use discontinued, with the door opening converted into a window. Additionally, the wall facing the north façade of the main room and the beveled part has undergone repairs and restoration after damage and destruction to the original wall. The original window in this wall has been closed. Other windows, as seen in old photographs, are double-leaf and wooden.

The kitchen is accessed from the hall through a single-leaf wooden door placed in the original opening (Figure 11). In its original state, the kitchen had a window opening facing the terrace. However, when the building was converted into a boutique hotel, the window was closed and transformed into a niche. Based on oral history research, it has been determined that there was a fireplace in the same wall that was closed by the users. The placement of the fireplace in the kitchen was confirmed by combining this information with the projection of the original chimney on the roof and data obtained from written sources. When the building was converted into a boutique hotel, the fireplace was closed, and a bathroom was added in front of it. The wooden shelf niche in the kitchen, as seen in elevation photo dated 2015, was created

in the second period by closing the original window. The original wooden sill of the stone-framed window facing the north façade is still present. Based on a comparative study with the surrounding area, the kitchen windows, in their original state, are double-leaf wooden windows, with wooden shutters, wooden, and stone jambs. The original iron hinges for the wooden shutters are present on the façade. The walls were originally plastered and painted. The original floor, as determined by a comparative study within the building, is made of timber. The original ceiling, according to information from written sources and a comparative study with surrounding buildings, is a wooden beam ceiling. In the second period, based on traces from the building and oral history research, it is observed that the kitchen was moved to the terrace, and the window in the north wall was closed, converting the wooden shelf niche into a cupboard. Based on written sources and oral history research, it is known that the kitchen section was repaired and renovated with modern techniques following the damage and destruction in the wooden-frame walls filled with stone.

Figure 11. (a) Main room, and (b) kitchen used as a room, in 2021

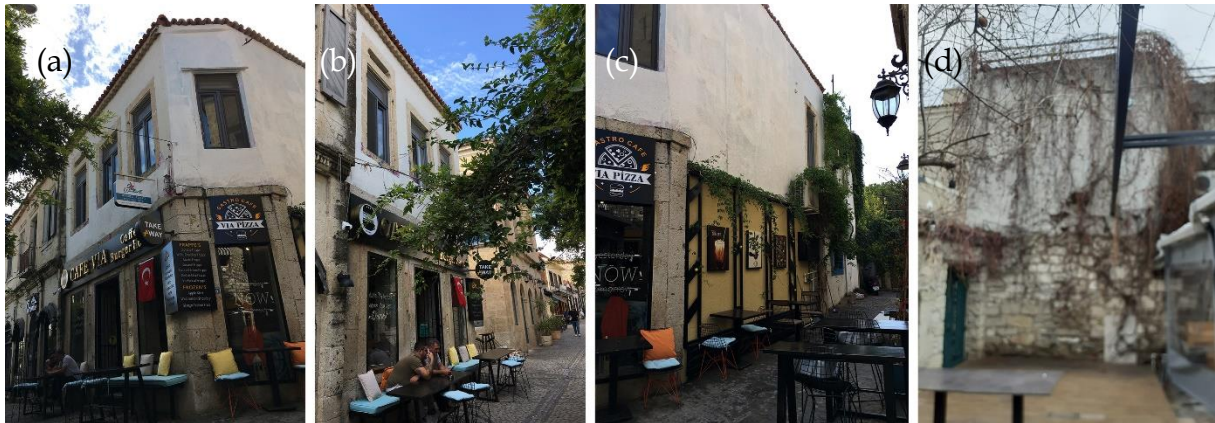
The eastern façade of the building is covered with cut stone on the ground floor (Figure 12). The upper floor, due to traces of plaster and paint visible in old photos and based on information from written sources and comparative studies with nearby buildings, is determined to be plastered and painted. The stone jambs and stone floor cornice on the eastern façade are original. On the upper floor, the demolished balcony and the balcony door, which was converted into a window, have been replaced with a balcony featuring an iron railing. The balcony is supported by a wrought iron element, according to traces in the structure and data obtained from written sources. In old photos, double-winged iron windows and iron railings are visible on the ground floor. In the angled section, the original window has been converted into an iron door. As a result of the balcony's demolition, the balcony door has been closed and turned into a window by the users. The windows on the first floor, as seen in old photos, are double-winged, without divisions, and wooden. In the angled section, Ottoman-style roof tiles eaves cornices have disappeared and been replaced with plaster eaves cornice.

Figure 12. Façade views of the building, (a, b) eastern, (c) northern, and (d) western

The northern façade (except for the cut stone-clad angled ground floor) is considered to be plastered and painted based on comparative studies with surrounding buildings (Figure 12). The stone jambs on this façade, where the original residential entrance is located, are original. Traces of a closed window are visible on the façade. It has been determined through comparative studies with the surrounding area that the windows of the workshop and storage have iron grilles. Based on traces from the building and comparative study in the building, it is believed that eaves cornices on this façade were originally made of Ottoman-style roof tiles.

Due to repairs, the eaves cornices made of Ottoman-style roof tiles have disappeared from the first floor of the building, and traces of the closed window are visible. The façade of the

renovated kitchen is plastered and painted, and its wooden window, as seen in old photographs, is divided into three sections. The terrace is surrounded by a mosaic parapet.

Today, the western façade is largely covered with ivy; however, in its original state, the façade was made of unplastered rubble stone on the ground floor, and plastered and painted on the upper floor (Figure 12). A terrace with a stone parapet is visible on the upper floor. The stone jambs of the vented door leading to the terrace on the western façade are original. In this stone-arched opening, a wooden, double-leaf door has been identified through comparative analysis. This façade also features a stone-arched, wooden shuttered, double-leaf wooden window. Based on traces from the building and internal comparative analysis, it is believed that there was Ottoman-style roof tiles eaves cornice. The chimney of the kitchen fireplace is visible on this façade. It is known that traditional houses in Alaçatı commonly had wells in either shared or individual gardens, which were crucial for water supply. It is believed that the space created by the western façade was intended for a well, important for water provision in the shared garden. The ground in front of the well, which belongs to the building, is paved with stone. The façade of the kitchen added to the terrace in the second phase is plastered and painted, while the restroom façade is made of unplastered rubble stone.
